# BUREAU OF SHIPS GROUP

## TECHNICAL INSPECTION REPORT

### U.S.S. PENSACOLA (CA24)

#### TEST ABLE

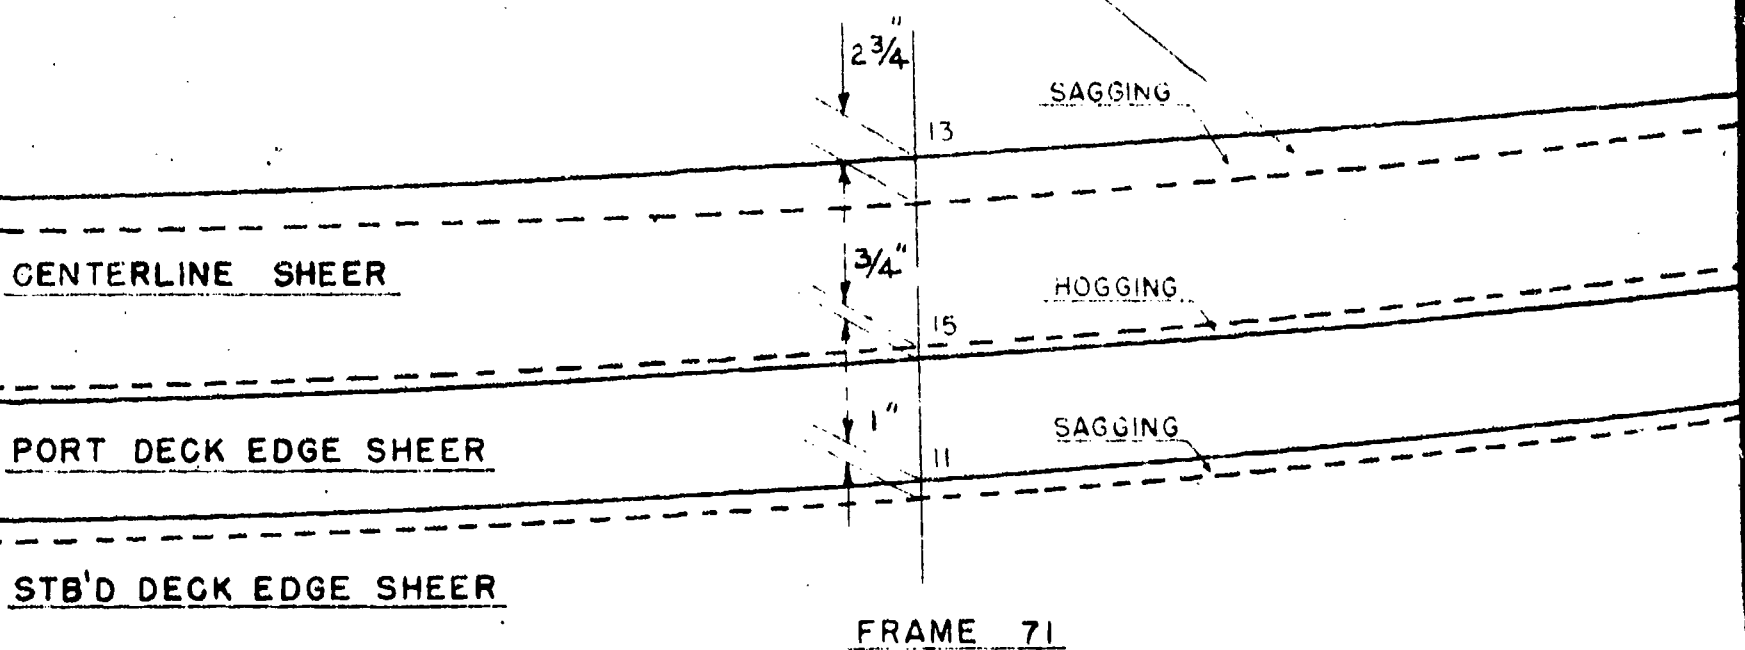
SHEER LINES - PROFILES

SAGGING OF CENTERLINE, AS SHOWN,  
IS PARTLY ATTRIBUTABLE TO LOCAL  
DECK DEFLECTION, SEE PLOTS OF  
TRAN'S SECTIONS AND SPECIAL SURVEY.

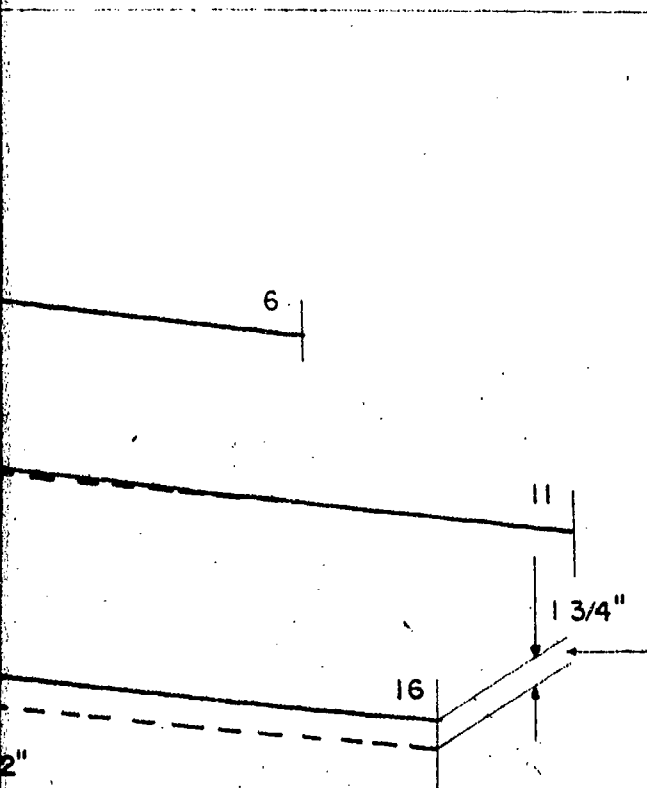
U.S.S. PENSACOLA CA 24  
TEST ABLE  
**DECK SURVEY**

MAX. TWIST IS THE SUM  
RECORDED AT FR. 29 & 97  
TOTAL TWIST = 5"

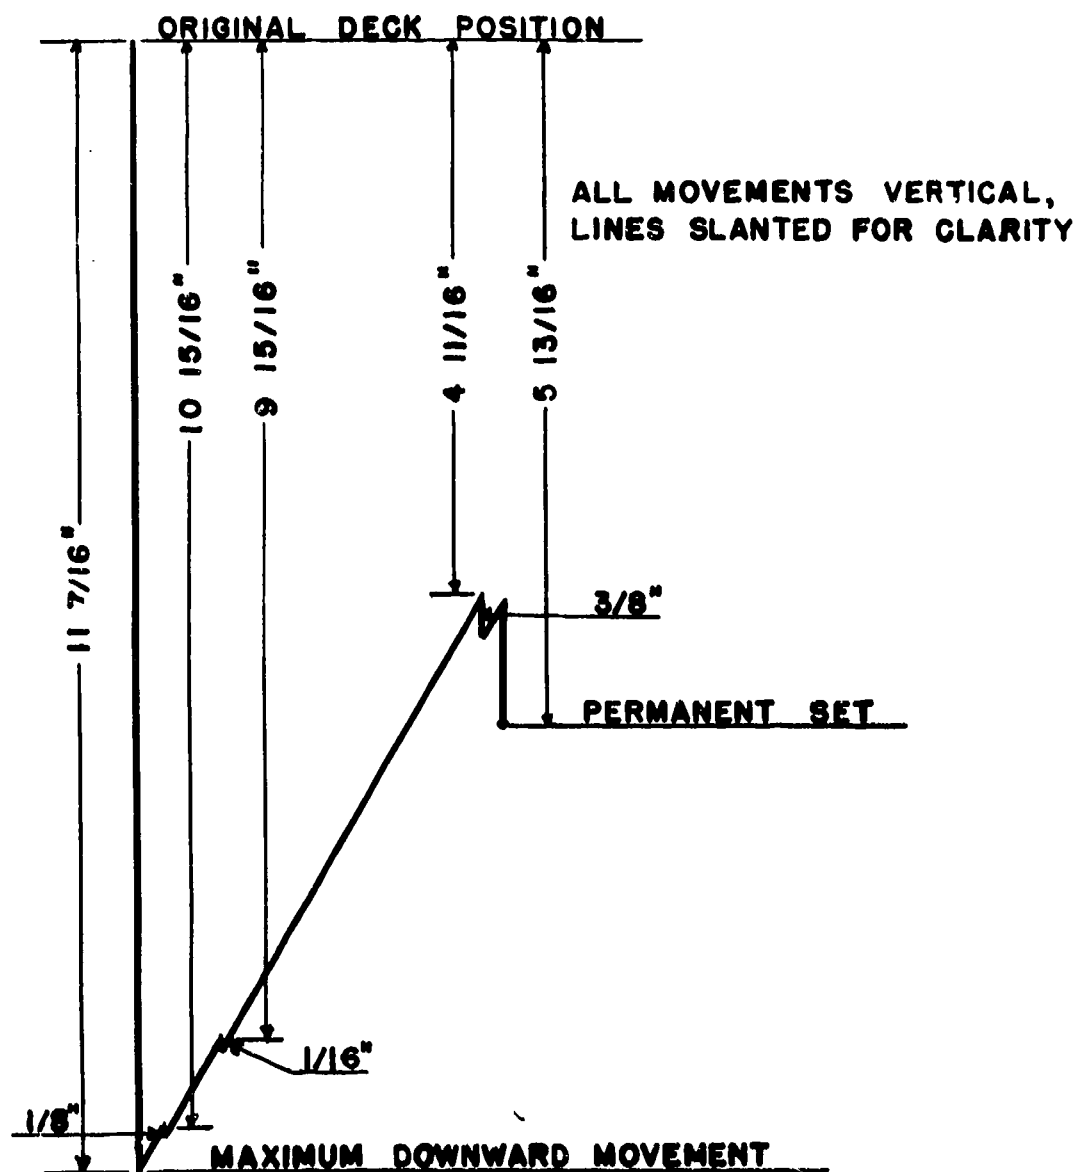
U.S.S. PENSACOLA, TEST ABLE, PLOT OF MAIN DECK  
MOVEMENT. SCRATCH GAGE LOCATION, 2ND. DECK  
FRAME 66 STBD. 16'-0" OFF CENTER LINE.

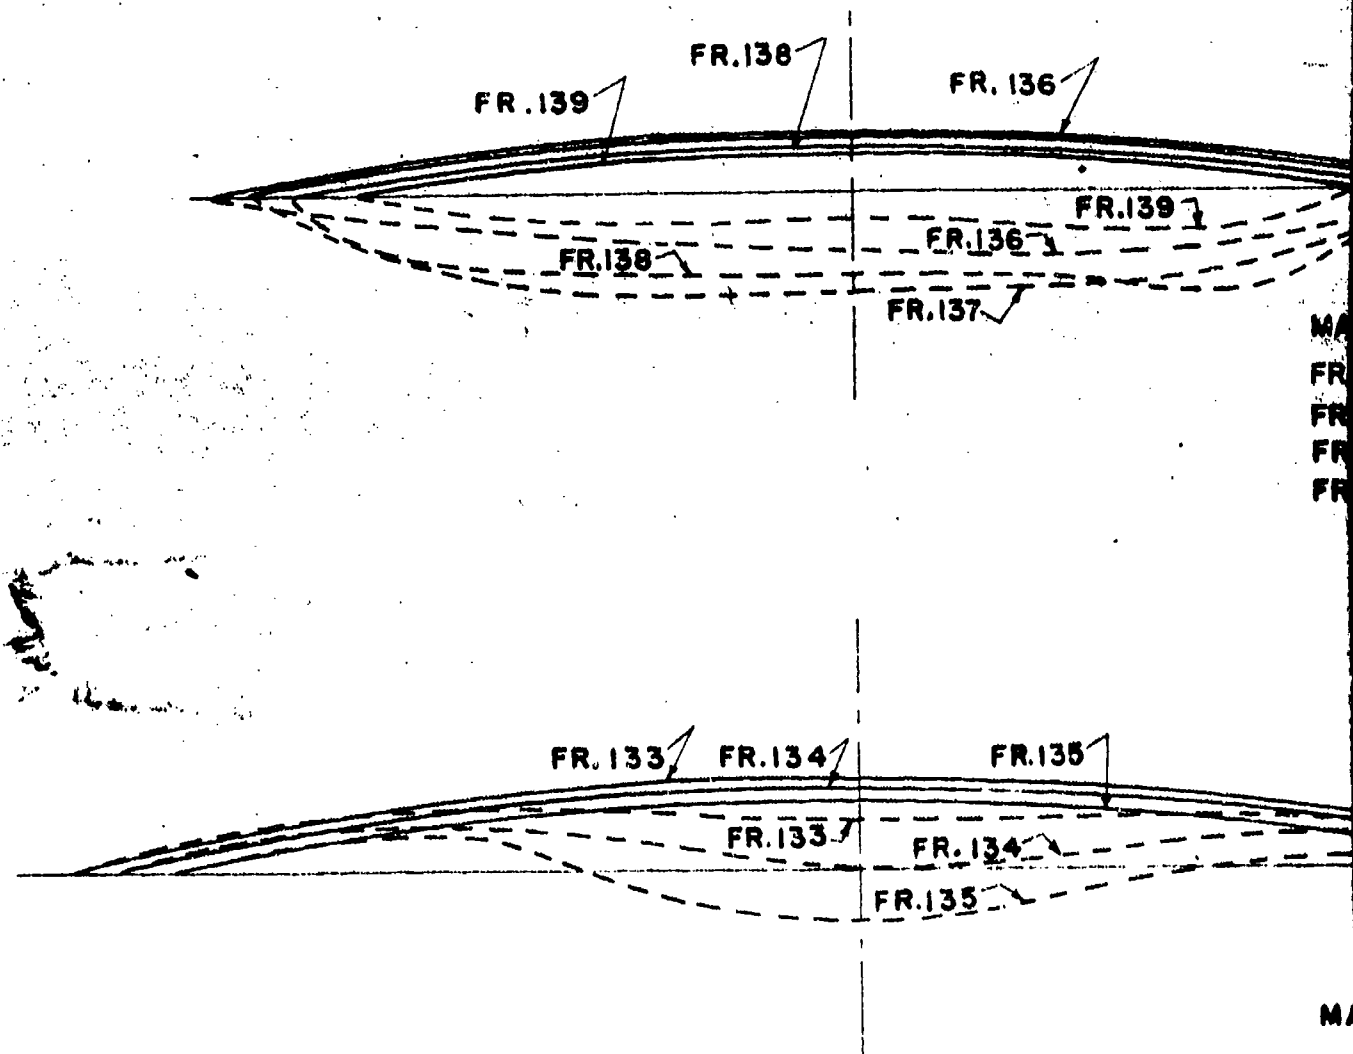
MAX. DEFLECTION - - - INCHES	
FR.139	4
FR.138	7 3/4
FR.137	9 1/2
FR.136	7 1/4

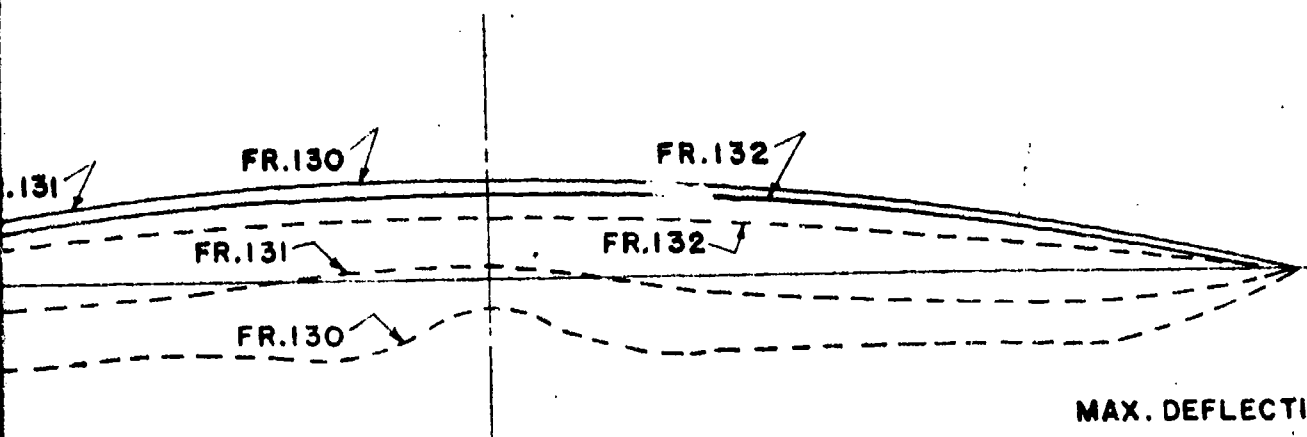
FR. 132	- - - - -	1 1/2
FR. 131	- - - - -	6 1/2
FR. 130	- - - - -	10 3/4

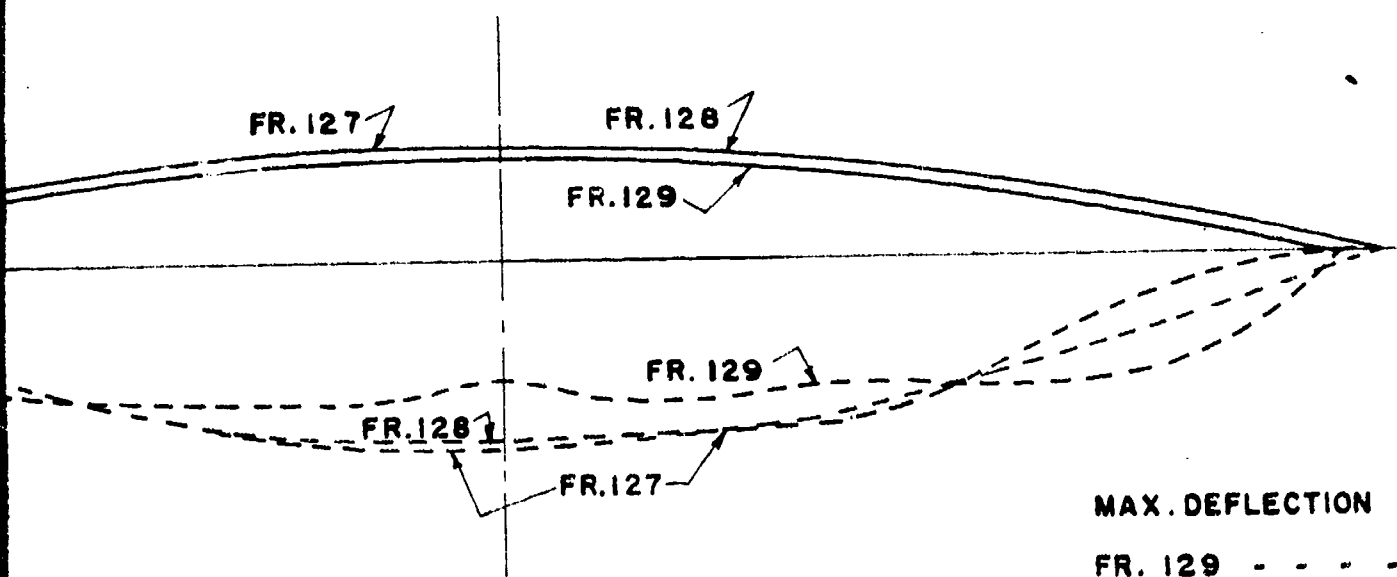
FR. 129	- - - - -	14 3/4
FR. 128	- - - - -	18
FR. 127	- - - - -	18 1/2

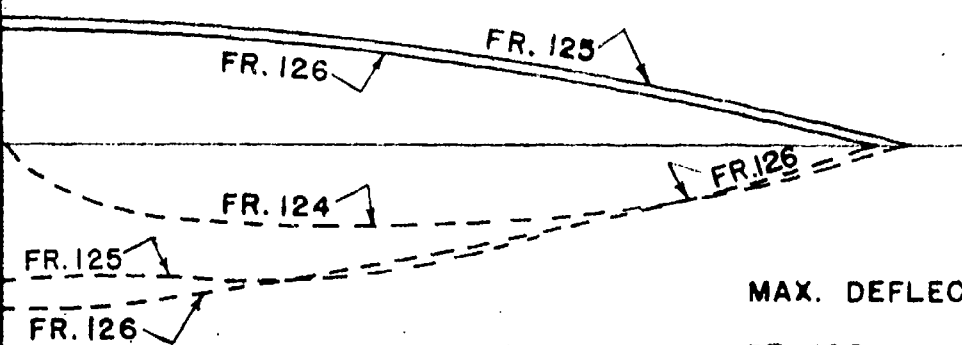
FR. 126 -----17  
 FR. 125 -----15  
 FR. 124 -----13 1/2

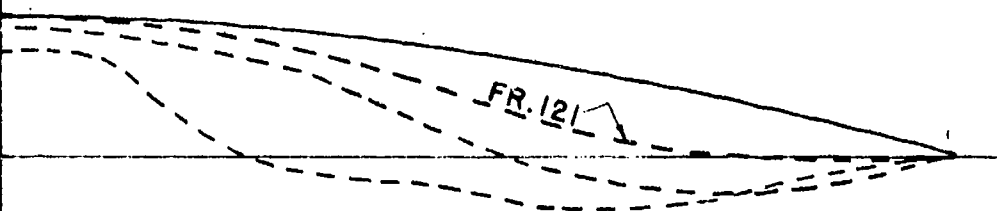
FR. 123-----10  
 FR. 122-----6 1/2  
 FR. 121-----4 1/2

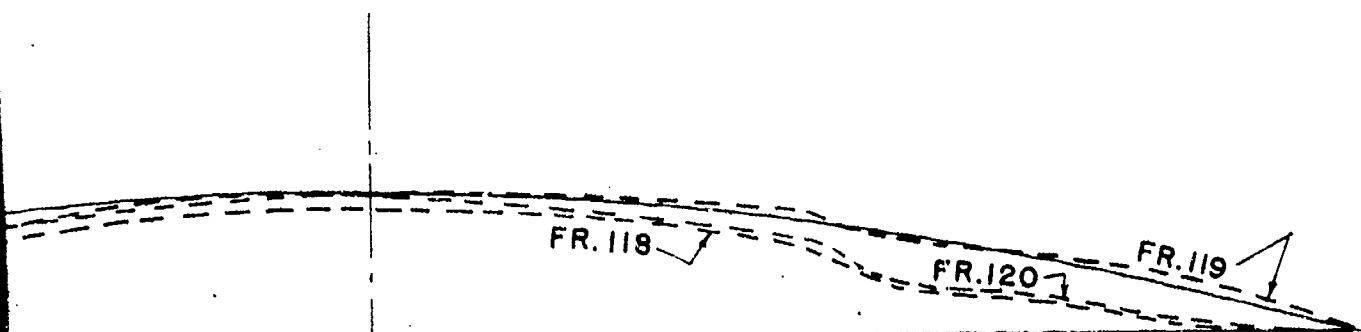
FR.120	---	3
FR.119	---	1
FR.118	---	3

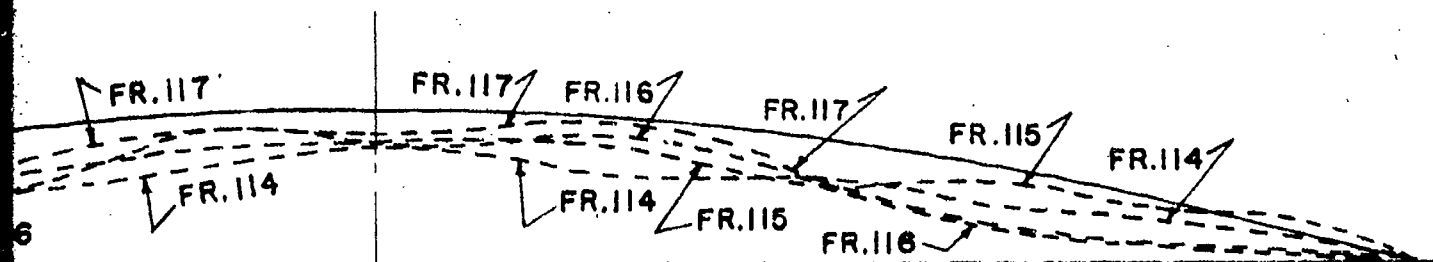
FR.117	---	4 1/2
FR.116	---	4 3/4
FR.115	---	3
FR.114	---	3 1/2
